Furniture Restoration Report

Client Name: Sciarini
Date: February 2011
Object name: Golden retriever coffee table
Dimensions: 41" L X 24" W X 24" D

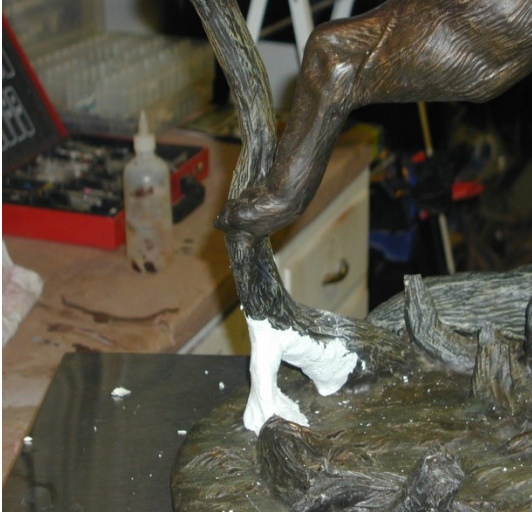
Epoxy reinforcement

The rear leg needed additional support. A metal rod encased with epoxy resin was inserted to reinforce the structurally weak curve. The epoxy resin was then carved to match the original texture of the piece. The repair was then colored with acrylic paint to match the original piece.

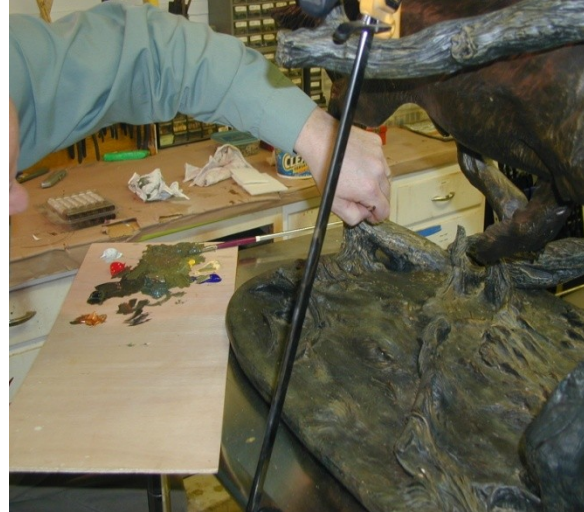
Matching the texture and color

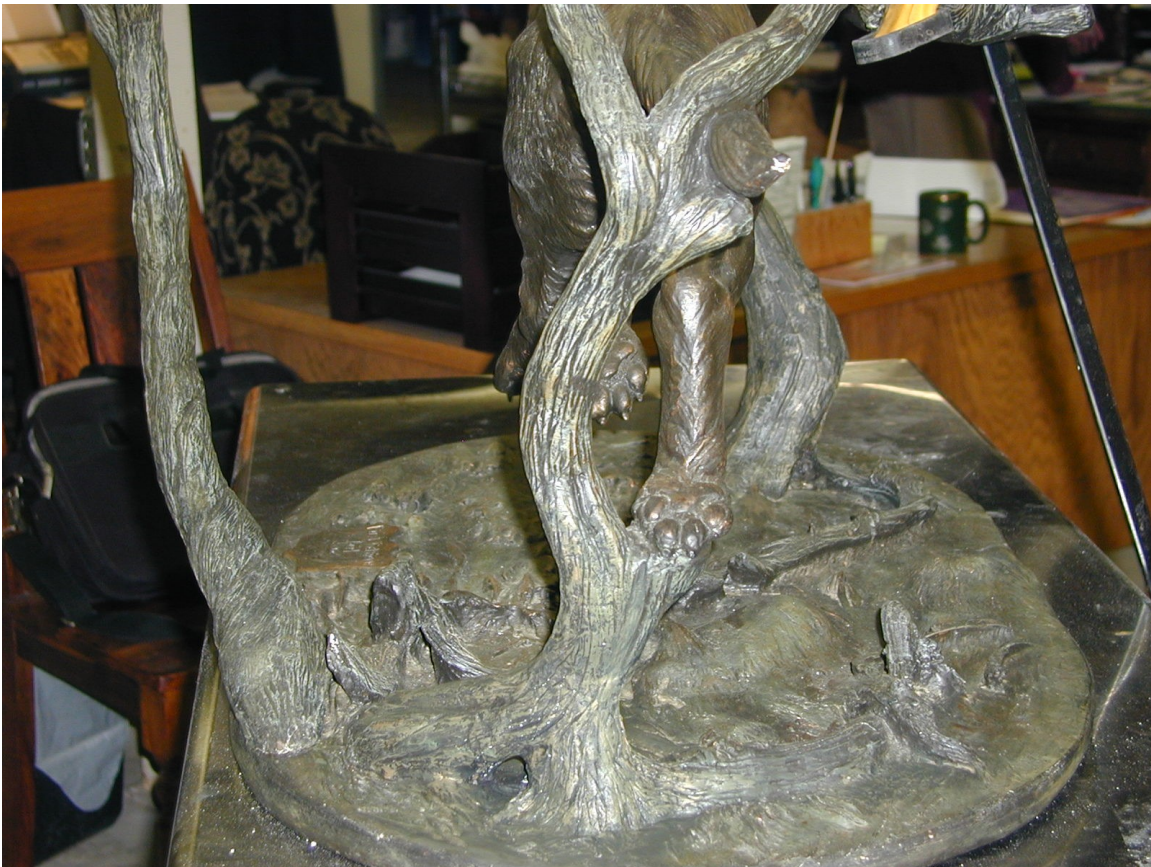
Completed repair of rear structure

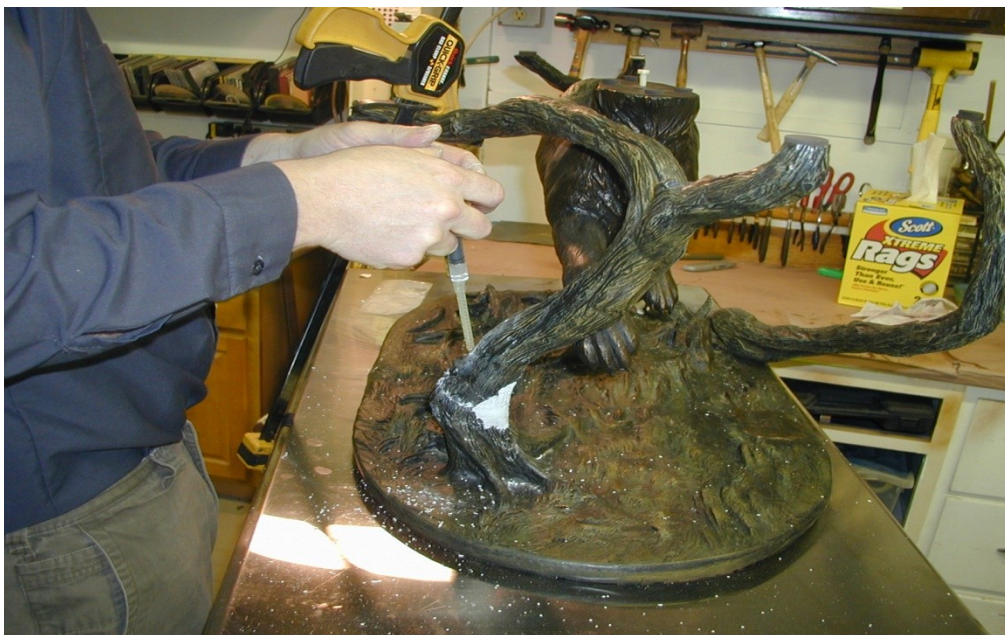
Epoxy Insertion

The front leg was cracked and failing due to the glass top weight. The piece needed support. Reinforcement by metal was not possible due to the curve. The leg was hollow. Two holes were drilled into the leg. 2 part epoxy glue was inserted in stages and at different levels to consolidate the interior of the leg. The glue was allowed to cure one week. The holes and original break were then filled and colored to match the piece.

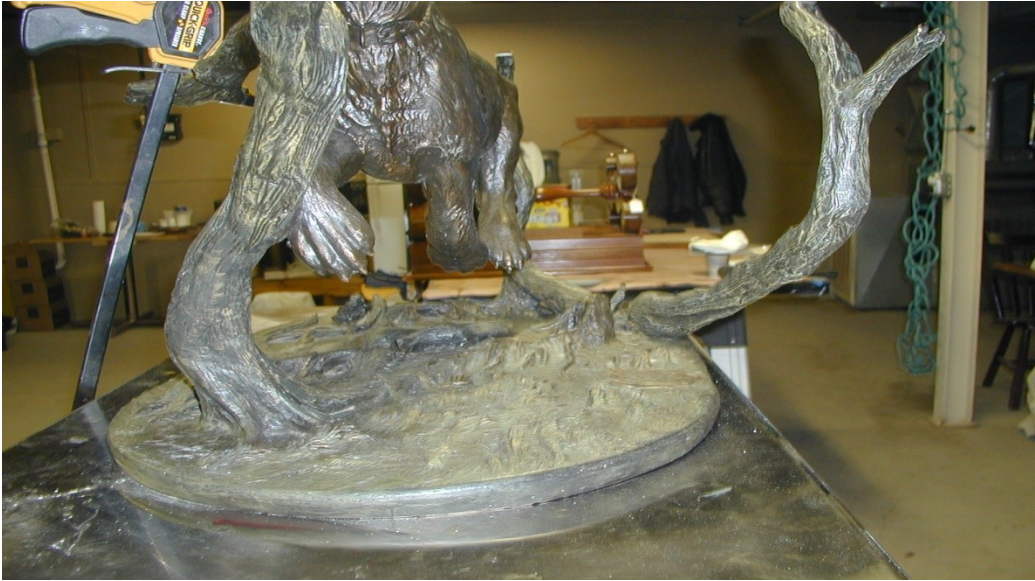
Completed Repair – Front leg

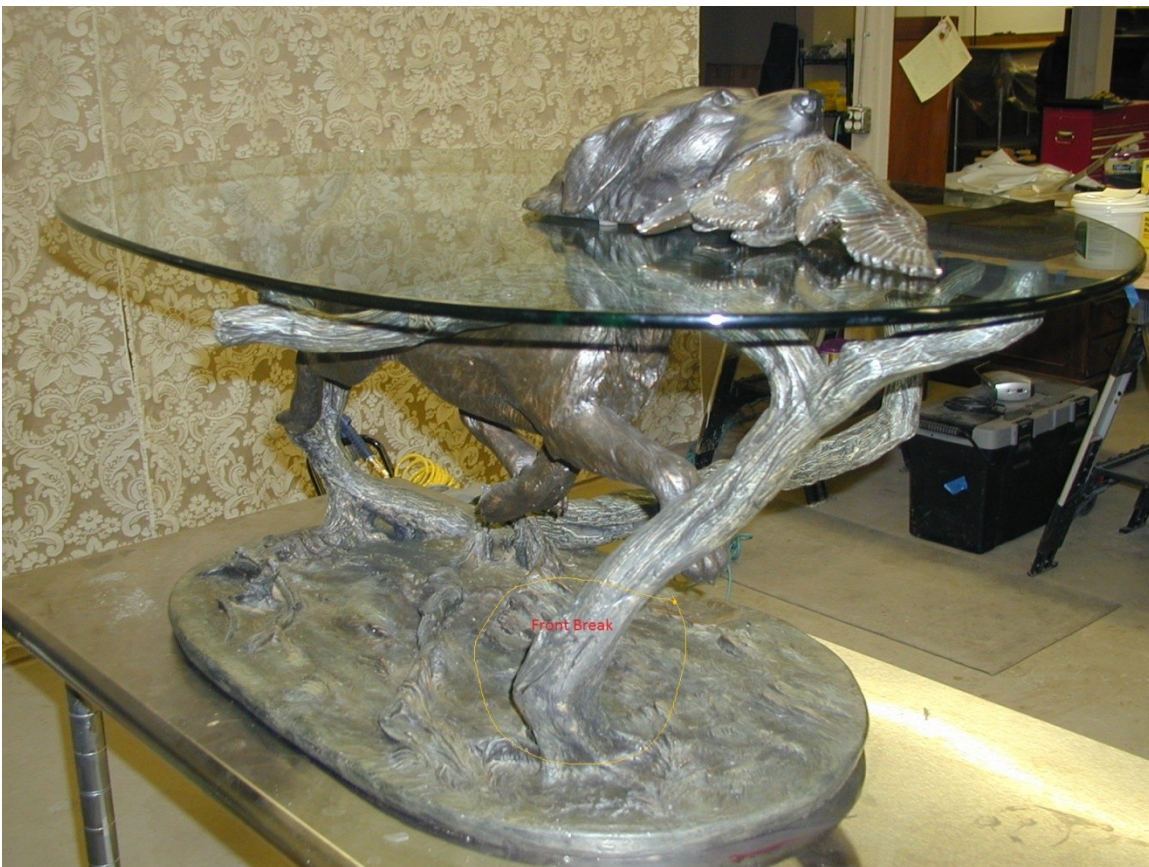
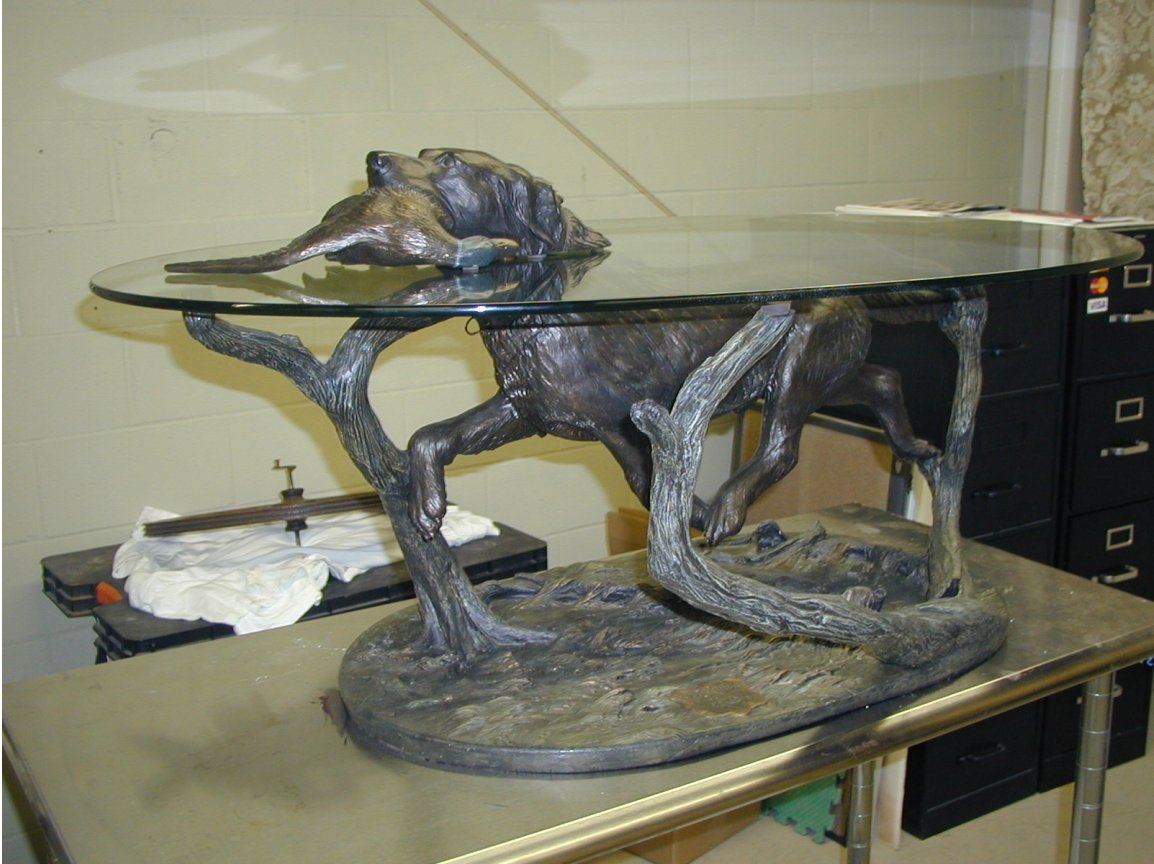
Completed Front & Back repair.
