Restoration Report

Client Name: Brandon Oaks Lutheran Church

Circa 1850 Lutheran Church replica made from the original wood of the church. The church was torn down in the 1970's to make a retirement community on that land. The replica was made by the church members.

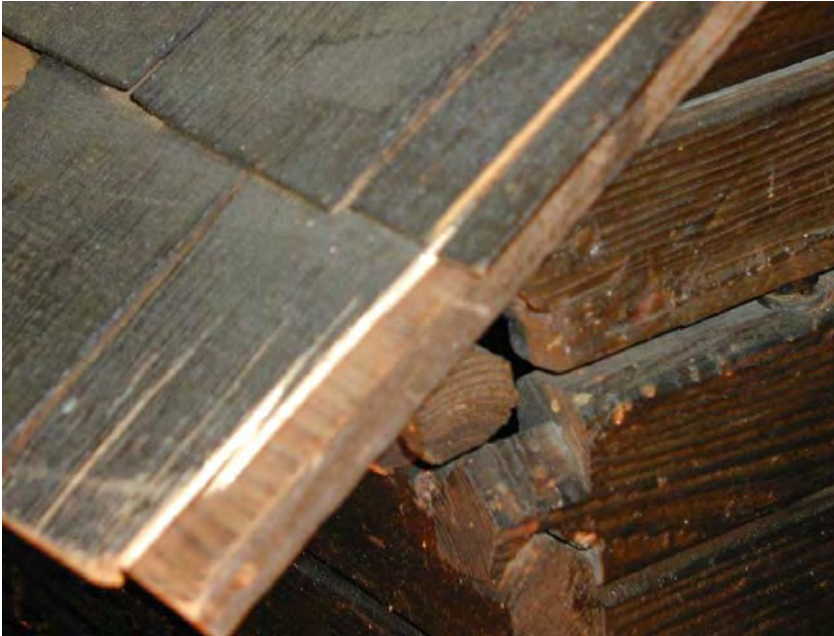
The roof: most of the shingles were in place and intact. Many shingles were cupped due to wood shrinkage.

Approximately 40 shingles were broken and needed replacing.

Missing/ broken roof tiles were replaced by handcrafted tiles made of balsa wood, given a scratch texture and stained with Chemcraft International Inc. Brand, color: warm brown stain and sprayed with Mohawk brand dark brown toner.

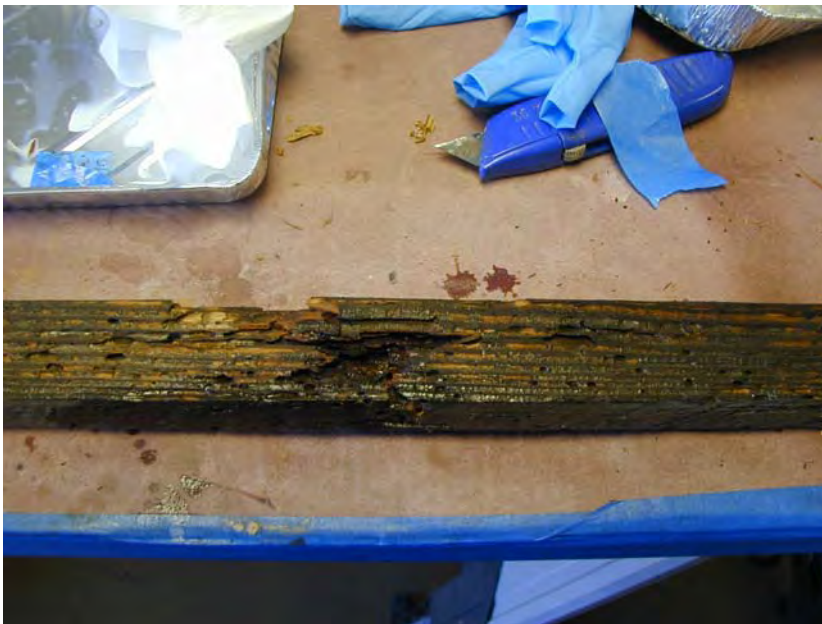
There is evidence of prior termite damage. Some of the termite damage was so extensive that treatment was required. The furniture was in good condition. The electrical system was in fair condition.

Termite damage

PC Petrifier Wood Hardener (wood consolidator epoxy) was used on broken outside slats to mitigate termite damage.

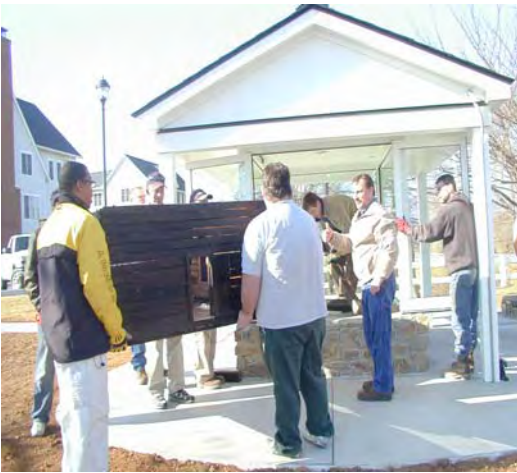
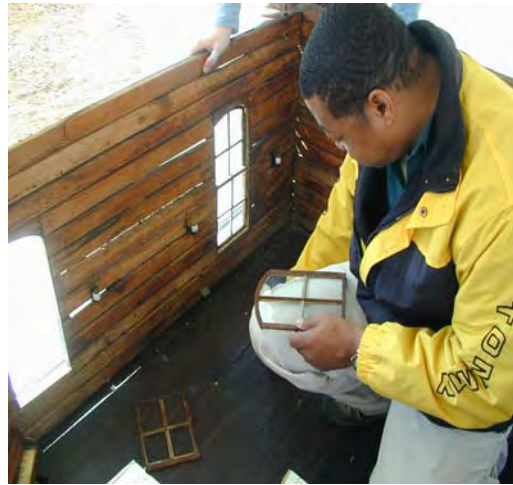
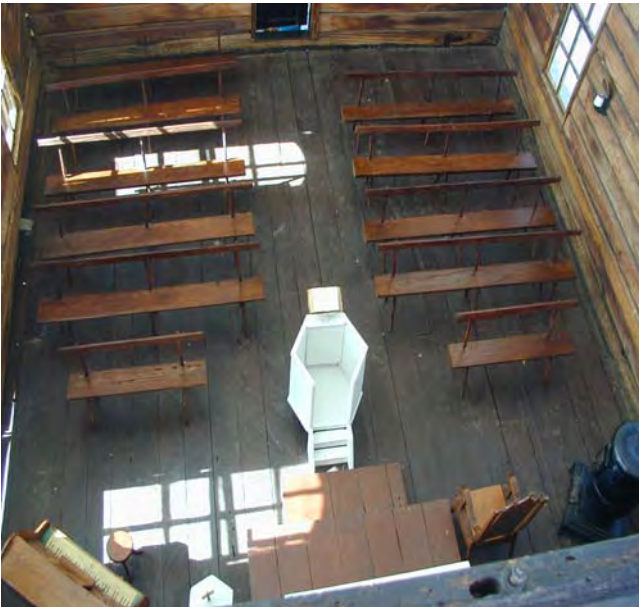
The church was delivered on February 13, 2009. In the process of installation several shingles were damaged and needed repair. The windows were glued in place and the furniture was installed. The lighting was activated and the roof was placed after shingle repair was completed. Workspace was left clean and ready for viewing.

Base setup and furniture placement
