Restoration Report

Object Description: Lane Cedar Chest, serial number 633060
Date of Manufacture 6/3/1936

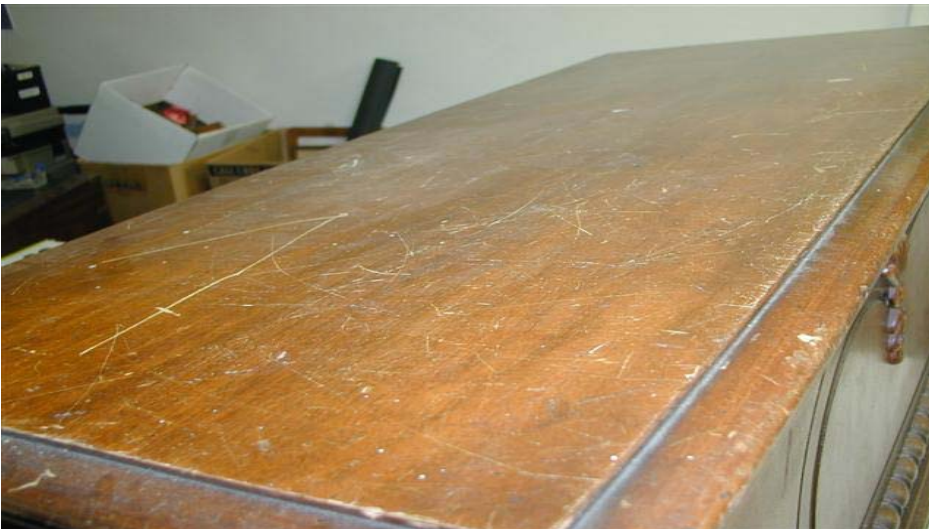
1. The walnut top has considerable wear and scratches through the finish into the wood. The front, sides, and back are in very good condition. The underside substrate is in very good condition.

6. The hinges were cleaned and painted to match the original paint finish.
7. The top was sanded from grit 100 to grit 220 to remove scratches in the wood. The top is walnut veneer with yellow poplar edging.

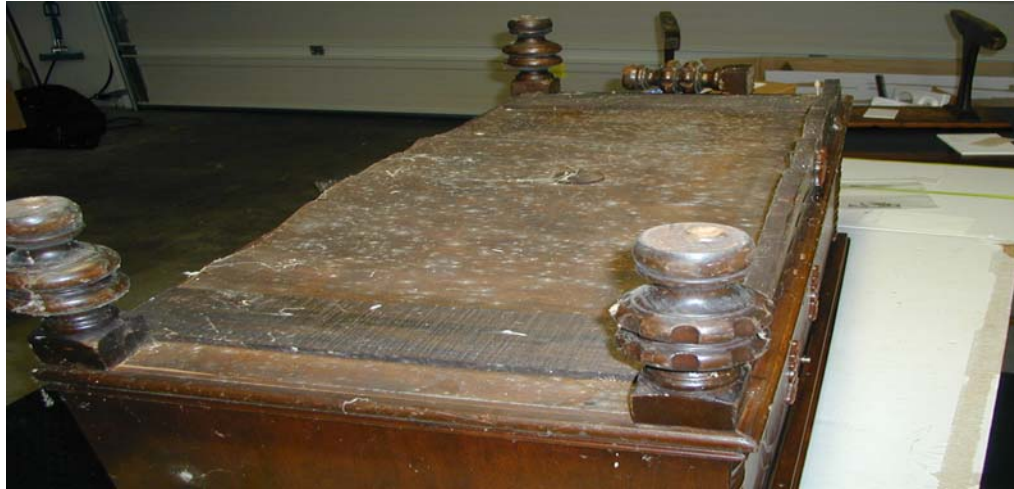
2. The underside is veneer covered and unfinished. It is in poor condition. The piece has been stored in a VA garage. The local humidity has separated and buckled the veneer from the substrate.

Underside Veneer – Portions of the veneer still had good glue adhesion. In order to affect repair to the entire veneer, the remaining glue line had to be lifted. A hot iron was used to melt the hide glue. The veneer was re-attached using PVA glue. Glue was applied to both glue sides, allowed to dry, the veneer was laid in place and a hot iron used to melt and set the glue. I was unable to use hide glue (the original glue) because clamping this section was not practical.

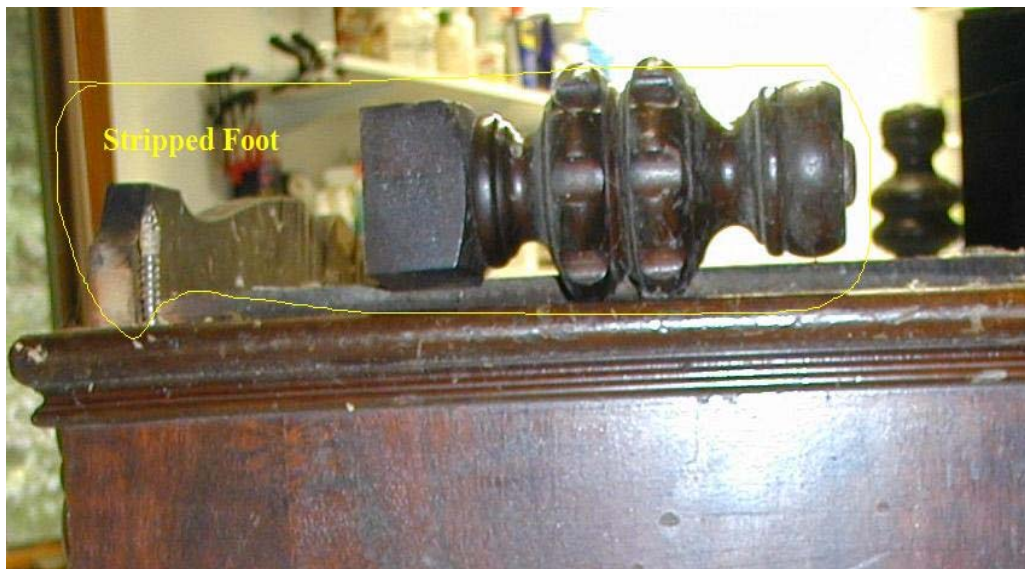
1. One foot needs repair. The feet are fastened to the case with a screw through the substrate and with glue.
2. The left proper front foot has been stripped from the screw and the glue line has deteriorated.

3. All feet had been reinforced with two 3 inch nails. I removed the nails and determined that only the left proper front foot needs repair.

Feet - The feet are attached by 3 inch screws and hi glue. The glue line was broken on both rear feet. The screw holes were stripped. Wood was added to the Screw holes and hide glue was used for adhesion.

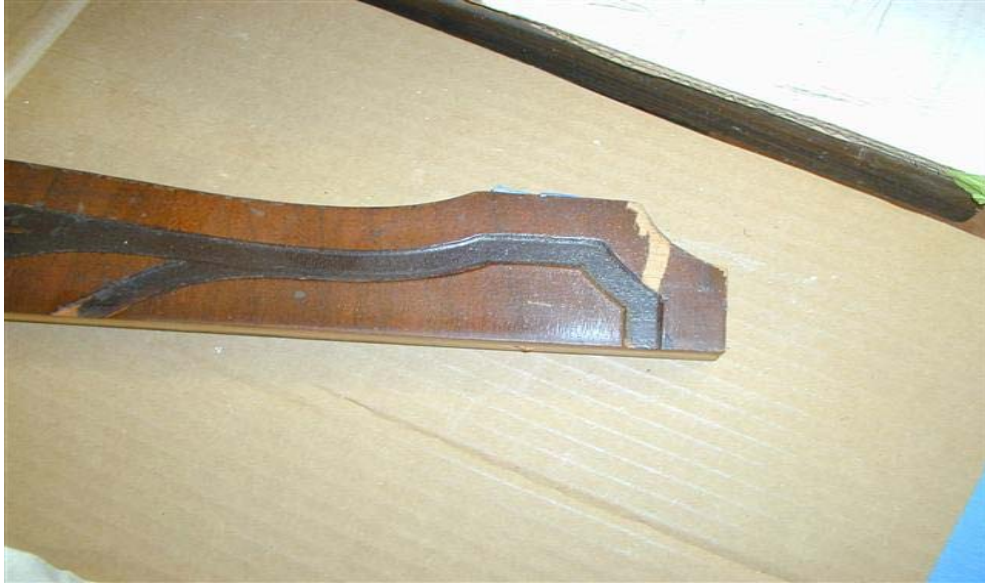
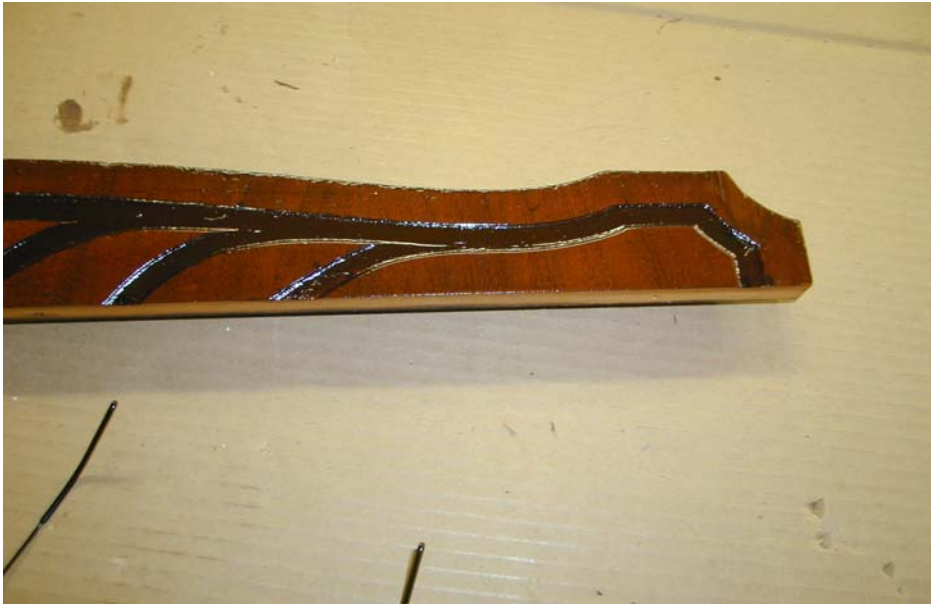
Veneer – There were 9 veneer repairs on the front of the apron and 6 on the back side.

Walnut veneer was used for the repairs.
Hide glue was used for the veneer repair.
Synthetic wood was used to repair veneer nicks.

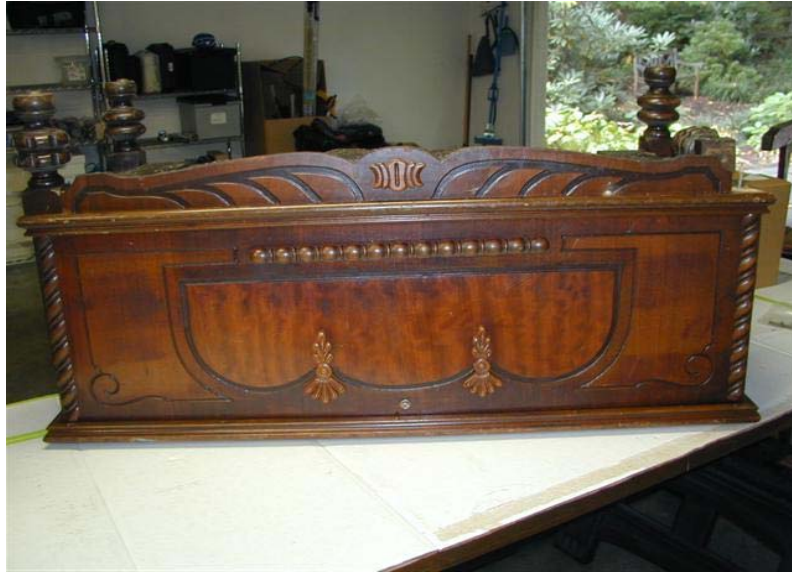
The finish is in very good condition. There are areas on the sides and front of incipient crazing. The condition has been caught early and is easily remedied.

1. The existing finish of the front and sides was dry sanded with 500 grit sandpaper to level the finish and eliminate finish deterioration.

One coat of Bysacki shellac was applied by spray gun to seal the existing finish.

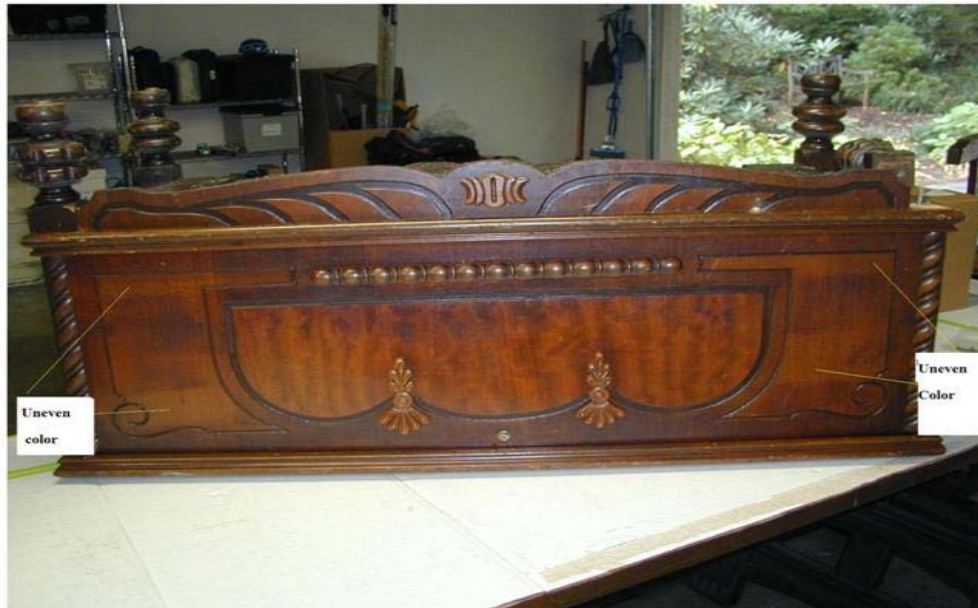
Uneven Color on side panels

2. The veneer coloring on the two front side panels and one side of the chest aged unevenly. Color was

evened out with Warm Brown oil based glaze and one coat of Bysacki shellac was sprayed on to bond the glaze to the shellac finish.

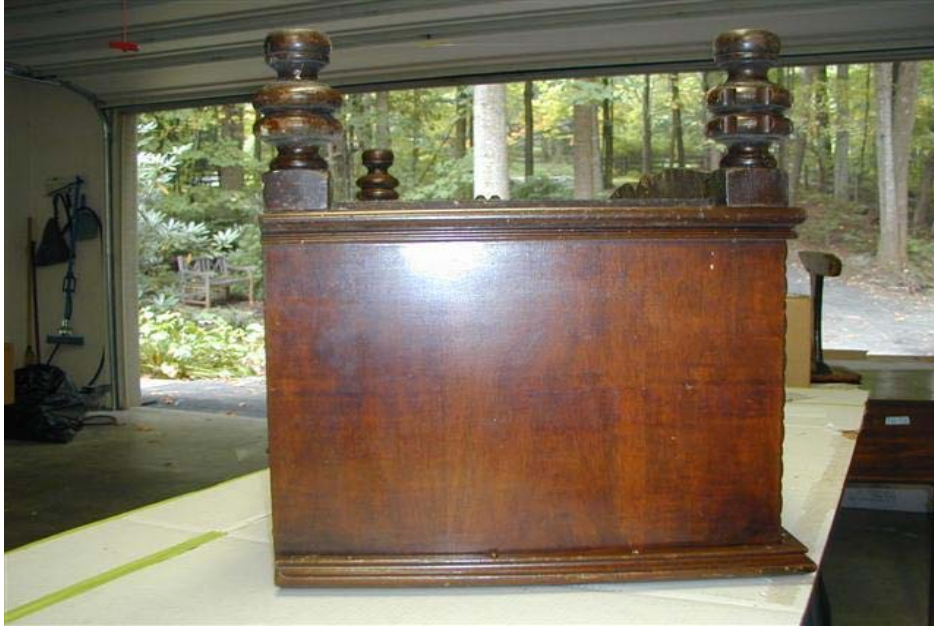
Uneven side panel color

4. The proper right side also had uneven color. Color was evened out with Warm Brown oil based glaze and one coat of Bysacki shellac was sprayed on to bond the glaze to the shellac finish.
