Restoration Report

Date: November 2007

Client Name: Lutheran Services

Object Description: Oak Library Table circa 1920's
Quarter sawn Oak top and sides. The legs are cylindrical columns with quarter sawn oak veneer. The columns resemble Ionic style columns without fluting. The legs are attached to a mortised platform with a 1 inch diameter steel rod through the leg and nut to secure. The platform fits into a tenon on 2 sides of each corner. The sides have an Ogee shape with the bottom of the apron beaded.

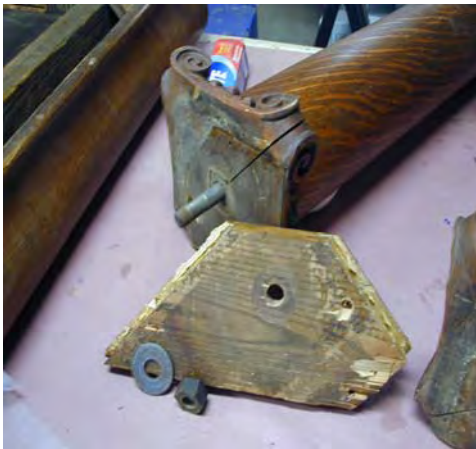
Leg and Plinth

Fair The table top is cupped. The massive legs are bolted to a corner plinth which is attached by way of mortise and tennon construction. The place of attachment is at the thinnest and weakest portion of the apron. Therefore, the apron is damaged with missing wood at each tennon. There have been numerous screws and nail applied to the table as previous remedies.

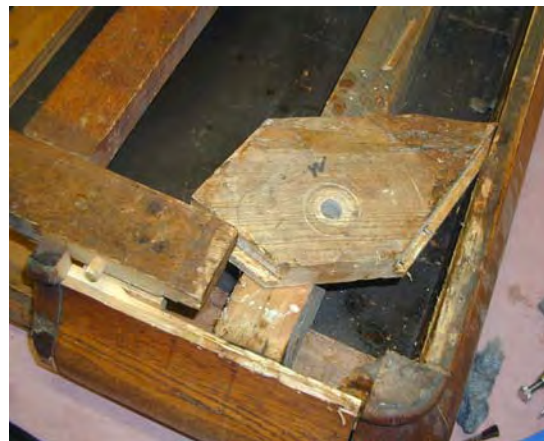
Plinth corner position

The wood has expanded and contracted over the years. The result is gaps at most joints.

2. The plinths were repaired first. Screws and nails were removed and old glue was removed from the plinth mortise and tennons. They were glued back in place with hot hide glue.

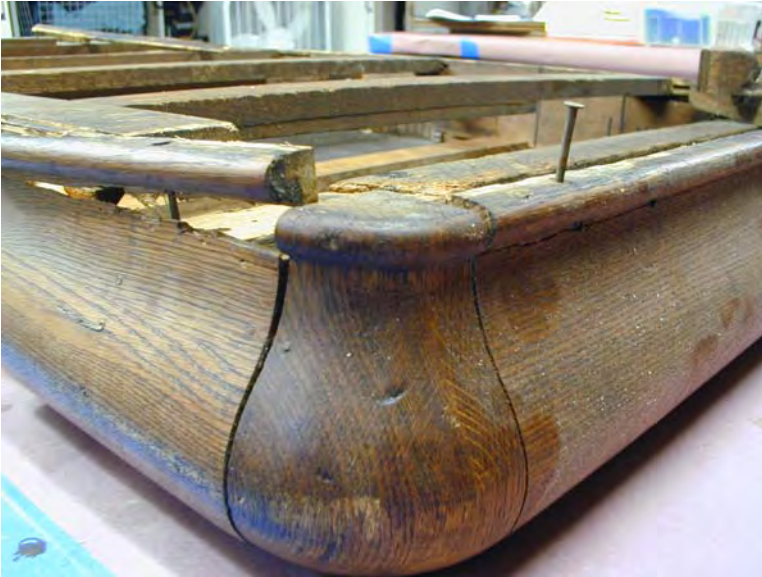
Typical corner and apron condition

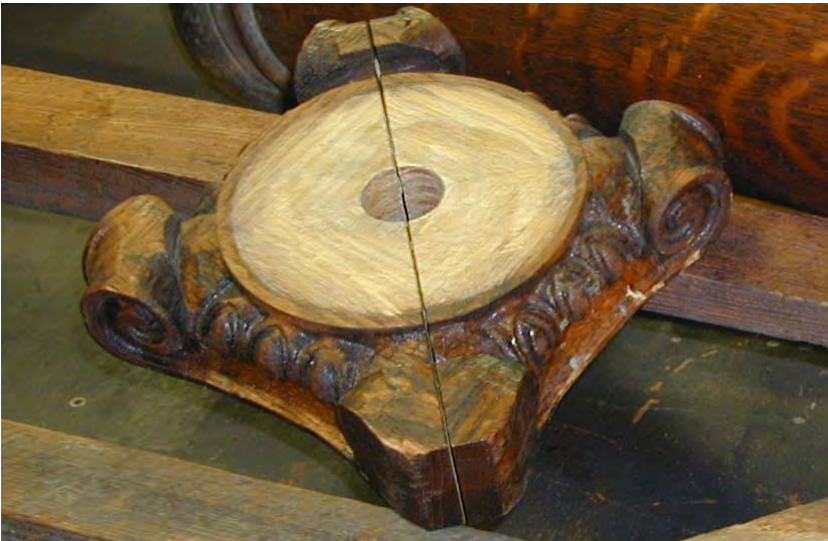
The legs are in excellent condition with the exception of gaps in the decorative molding.

1. The decorative molding on each leg was clamped to close the gaps. Where the gaps would not close, veneer was glued into the gaps and colored to match.

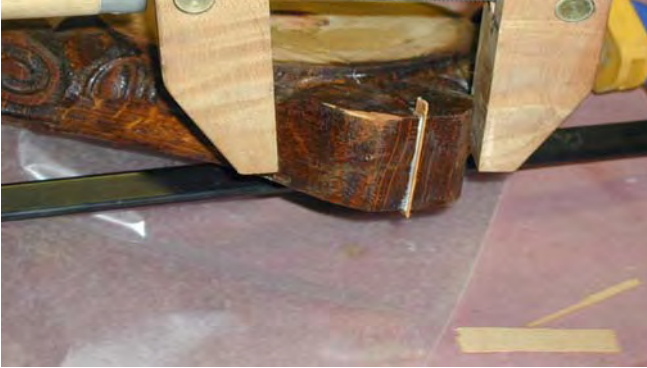
Wood Veneer gap filling

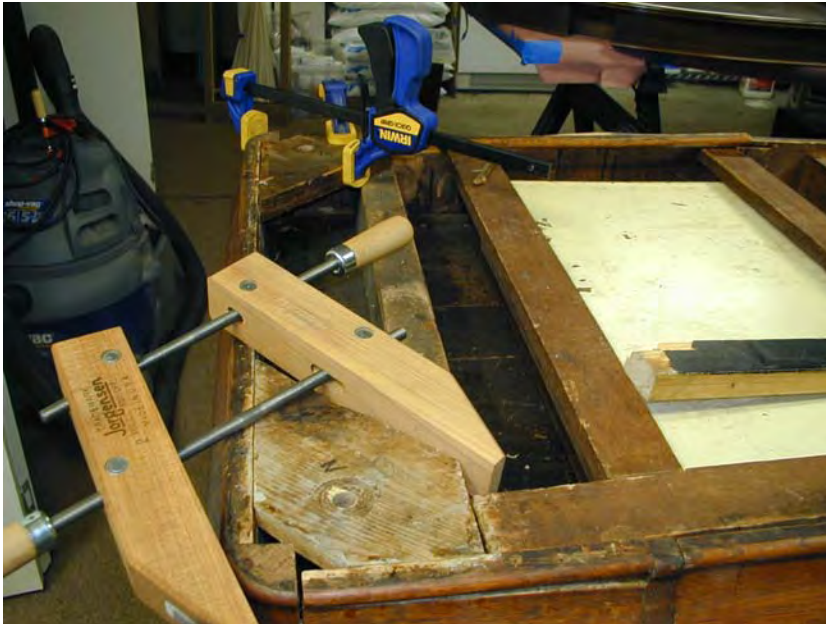
Plinth repair

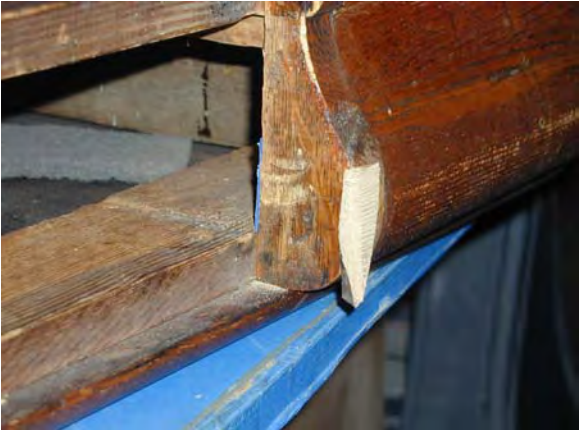
New White Oak scarf joint repair

4. Missing wood on the piece was replaced with new White Oak scarf joints using hide glue. The new wood was shaped and colored to match the piece.

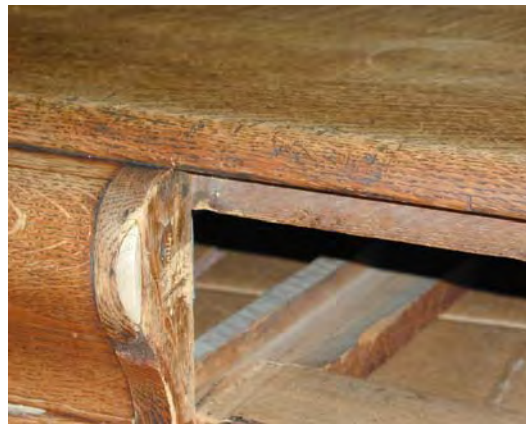
Shaped repair

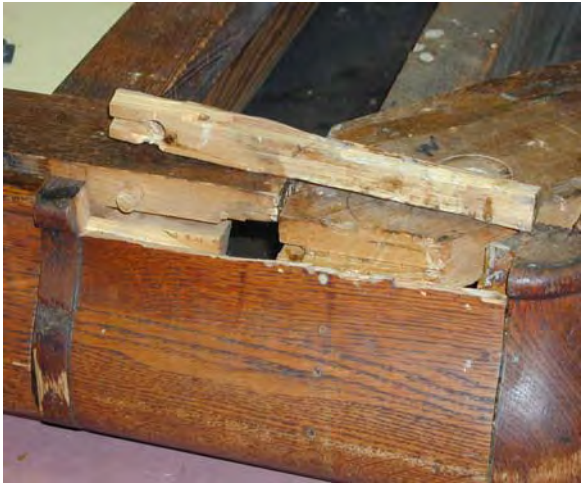
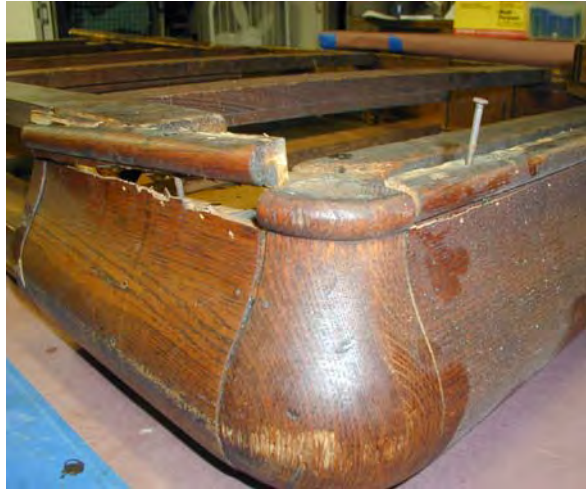
5. The sides of the table where the plinths are joined by way of mortise and tennon are serpentine. The result is that the plinth is tennoned at the thinnest part of the side. The result was the breaking of the side at the joint.

Using hide glue would not fill the gaps of missing wood at these breaks and would not have been strong enough to sustain the repair.

I chose to use hide glue for reversibility and epoxy wood filler for structural strength. Hide glue was applied to mating surfaces and allowed to cure. Epoxy wood fill/glue was then applied on top of the hide glue mating surfaces. The mating surfaces were then joined and clamped.

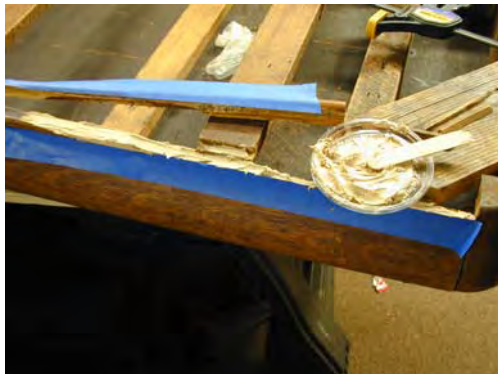
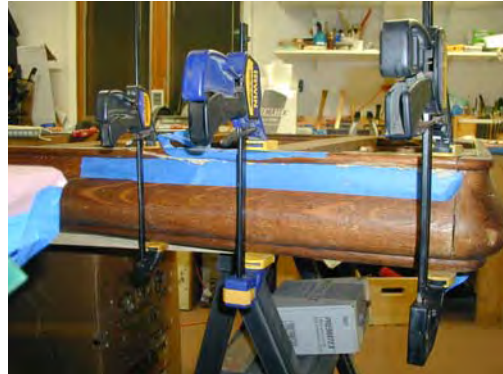
Epoxy wood filler/glue applied on top of hide glue and mating ends clamped
