Restoration Report

Date: June 2005

Object Description: Steamer Trunk; Canvas with leather. Contains a 2 compartment open interior shelf. The shelf had a cover. It is now missing.

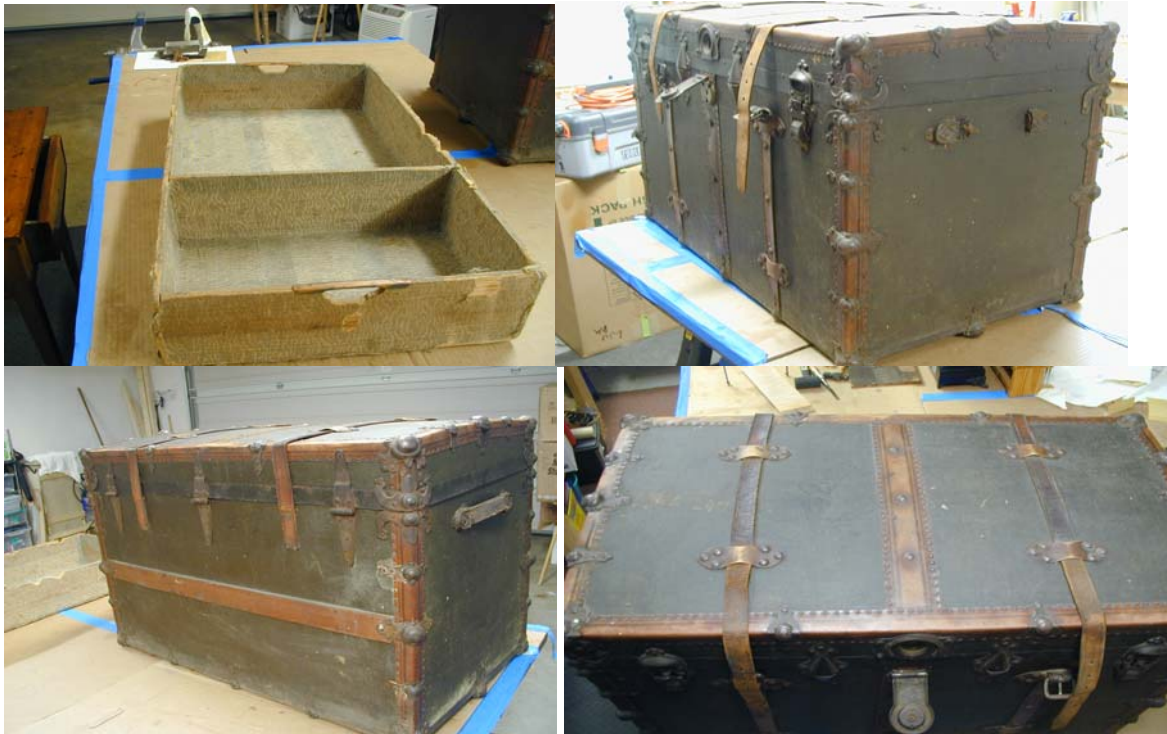
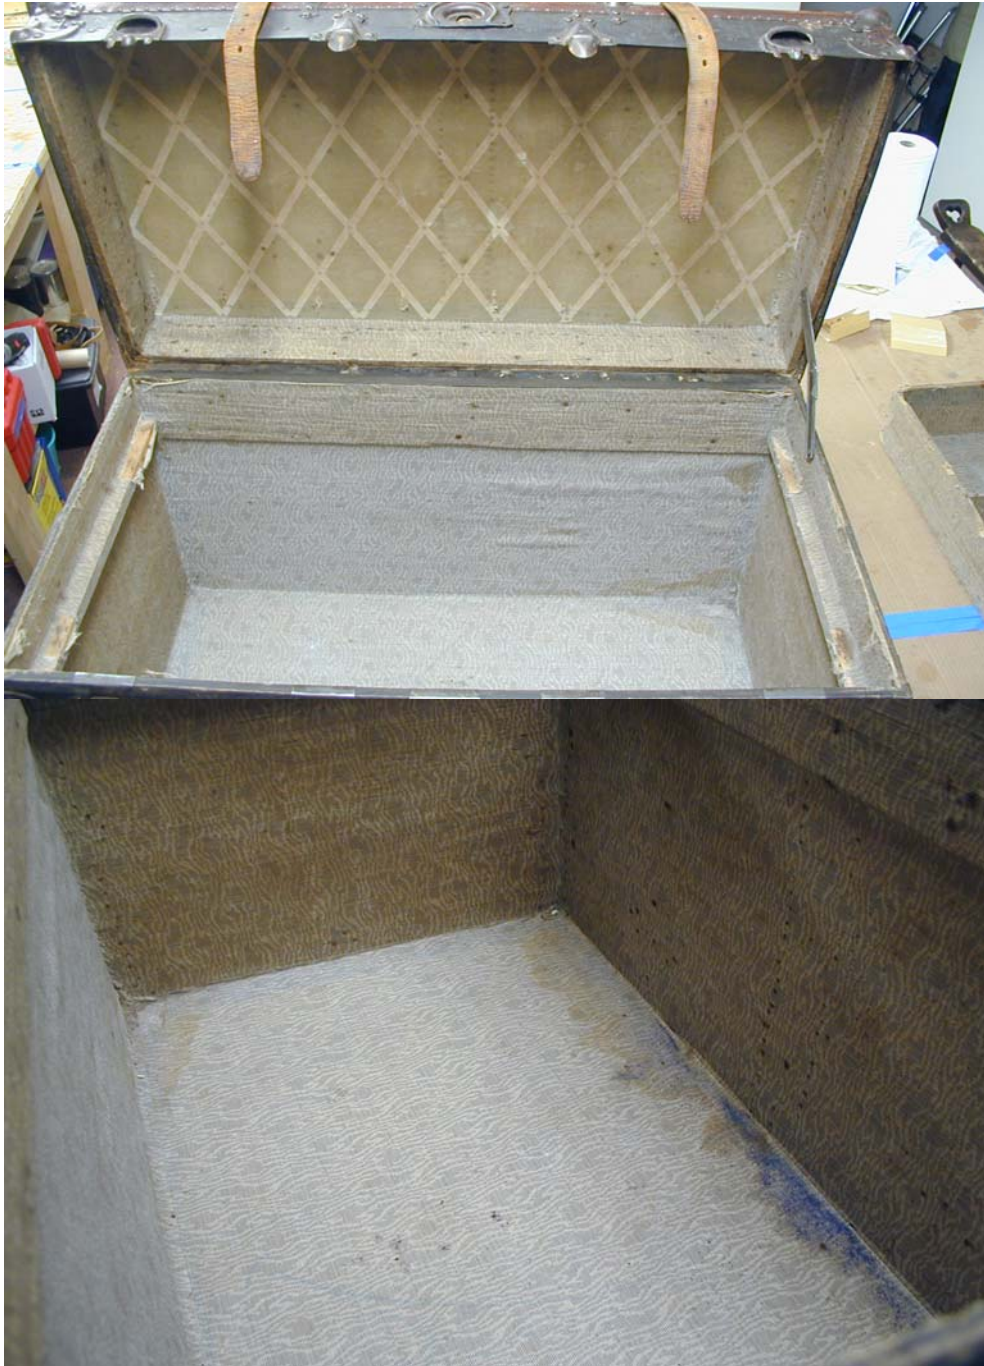
Original Condition Photos

General Condition: The condition of the primary wood is excellent except for the interior shelf. The shelf has gouged areas of wear.

There are stains but no mould. There are tears and worn spots but not sufficient damage to warrant replacement. There is a typical musty interior odor and stains from moisture and foreign matter.

Coatings condition: Very good. There is color and finish missing from the lower portions of the exterior canvas. There is minor crazing in a few areas on the shellac leather banding.

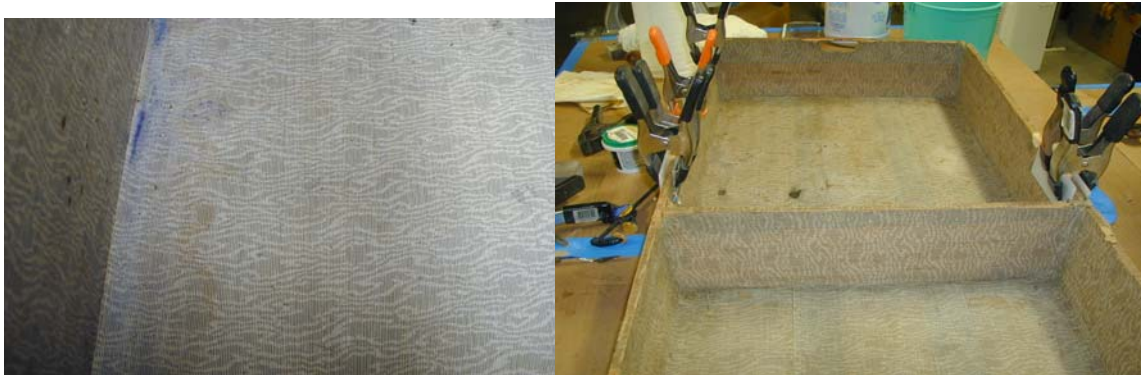
A number of cleaning and stain removal processes were tested. The most effective was ammonia and water. But I am disappointed in the results. There was very little benefit.

Photos after cleaning are below, but neither the before or after photos adequately show the age stains. The client has opted to leave the existing lining in order to retain the piece's historic integrity.

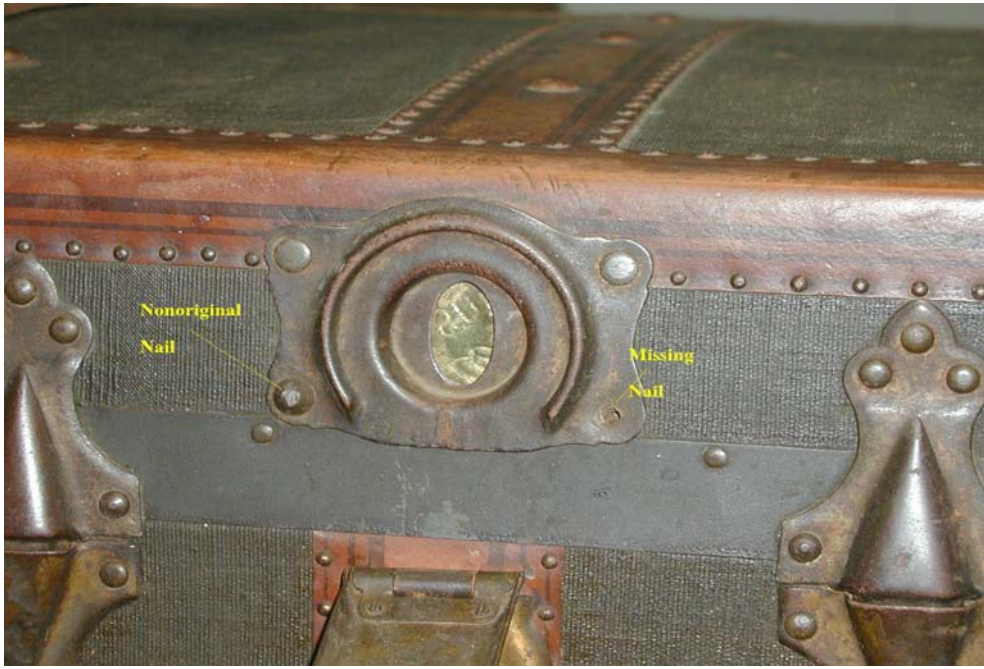
Exterior of the lock

At one point in the trunk's history, the trunk was locked and someone did not have the key to open it. The 2 bottom nails were removed and the interior of the lock was pushed out. (See the 2 photos below)

I will replace the missing nail but leave the non-original nail since it is a good repair.
The interior of the lock was repaired poorly.

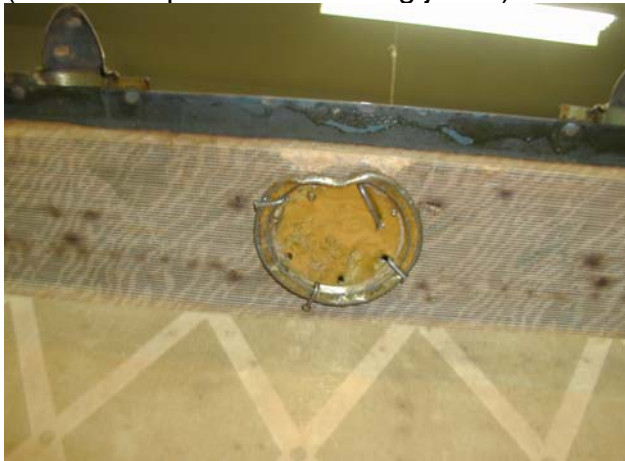
Interior of the lock – previous repair
(The brass plate is a canning jar lid)

I discovered that the interior brass plate was a canning jar lid. I can not purchase another plate without replacing the entire locking mechanism. This would remove the original lock and cause damage to the piece. I don't want to leave a hole in the interior. I fit the hole with a pine replacement and carved an oval hole to match the lock opening.

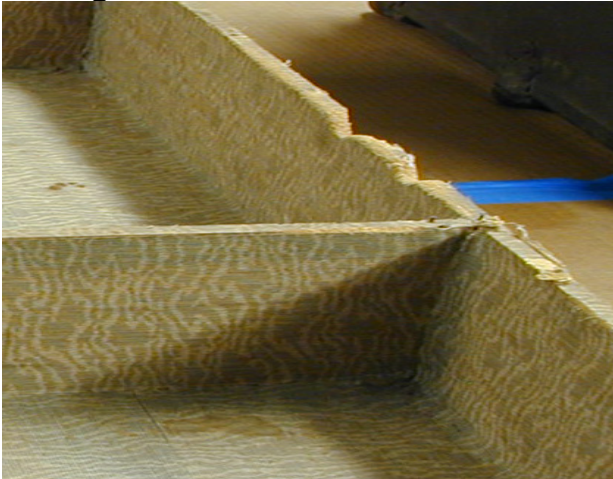
Damage

The interior shelf has 4 areas of wood damage on the top edges. The wood was worn or broken away. My original intent was to leave the damage as is, so as not to alter the integrity of the piece. After re-consideration, I decided that leaving the damage would not be consistent with the look of a well maintained antique. There are 2 acceptable means of making the repair.
