Restoration Report

Date: August 2006

Client Name: Scherer

Object Description: English Tall Case Clock circa. 1770-1790
Mahogany veneer with line inlay, broken arch pediment over turned columns. The waist door is a Gothic arch crotch mahogany. The base panel has 8 sided mahogany inlay stringing. The scroll board mahogany has inlay stringing. Ogee bracket feet are missing as is the plinth. The finial is missing between the arch pediment.

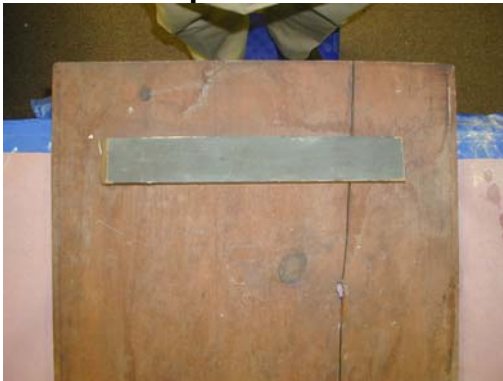
Previous Repair

1. The back of the clock has a compression crack. The crack was previously repaired by screwing a board over the crack. That repair was ineffectual. The board was removed and the screw holes filled with wood. The crack was clamped closed as much as possible and 2 butterfly keys were fabricated and glued in place with hide glue. The back was cleaned. The crack was not glued because compression cracks will not stay glued. There is a hole and missing wood along the crack between the butterfly keys. I chose to leave this distress as original. Filling the distress with new wood would take away original wood and the repair would look no better than the existing distress.

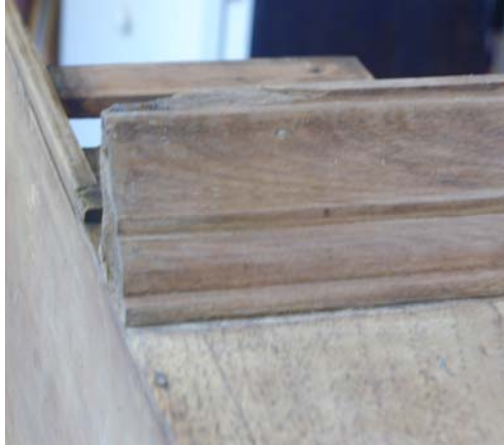
Broken molding

3. The molding under the hood on the proper right side was partially broken. I added a new mahogany piece with a scarf joint and hot hide glue.
