Restoration Report

Object Description: Lane Cedar Chest, serial number 633060
Date of Manufacture 6/3/1936

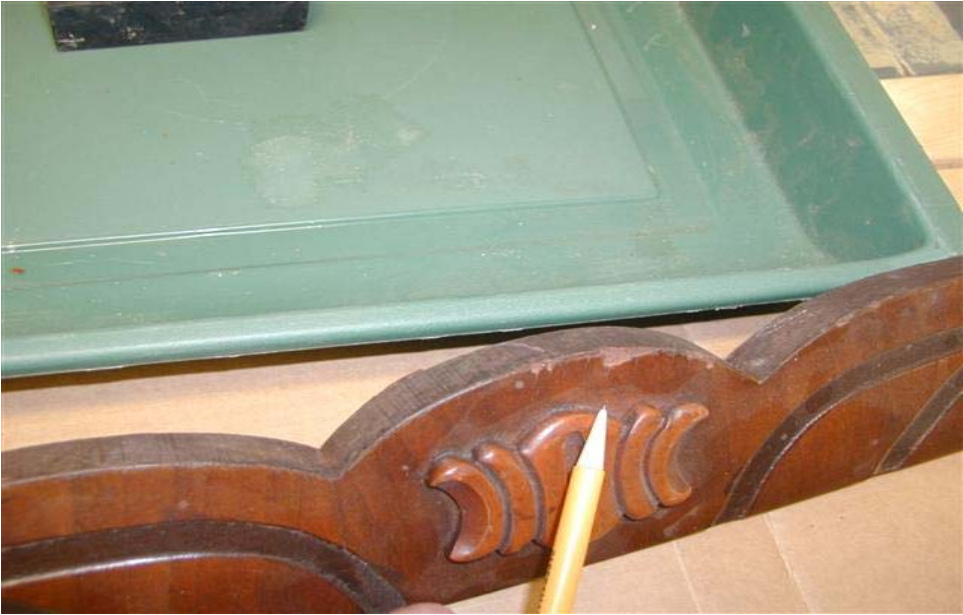
Before

Veneer – There were 9 veneer repairs on the front of the apron and 6 on the back side.

Walnut veneer was used for the repairs.
Hide glue was used for the veneer repair.
Synthetic wood was used to repair veneer nicks.
