Restoration Report

Date: August 2006

Client Name: Scherer

Object Description: English Tall Case Clock circa. 1770-1790
Mahogany veneer with line inlay, broken arch pediment over turned columns. The waist door is a Gothic arch crotch mahogany. The base panel has 8 sided mahogany inlay stringing. The scroll board mahogany has inlay stringing. Ogee bracket feet are missing as is the plinth. The finial is missing between the arch pediment.

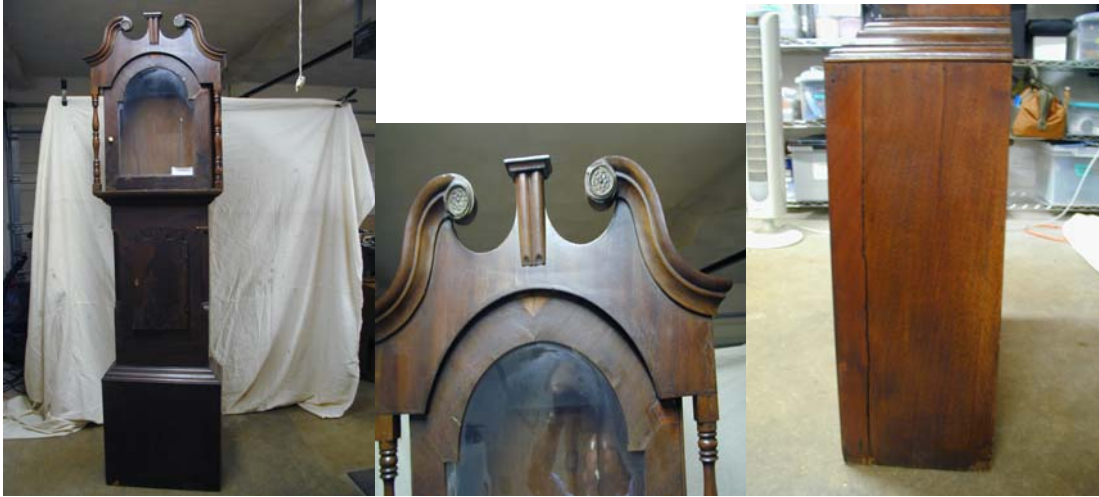
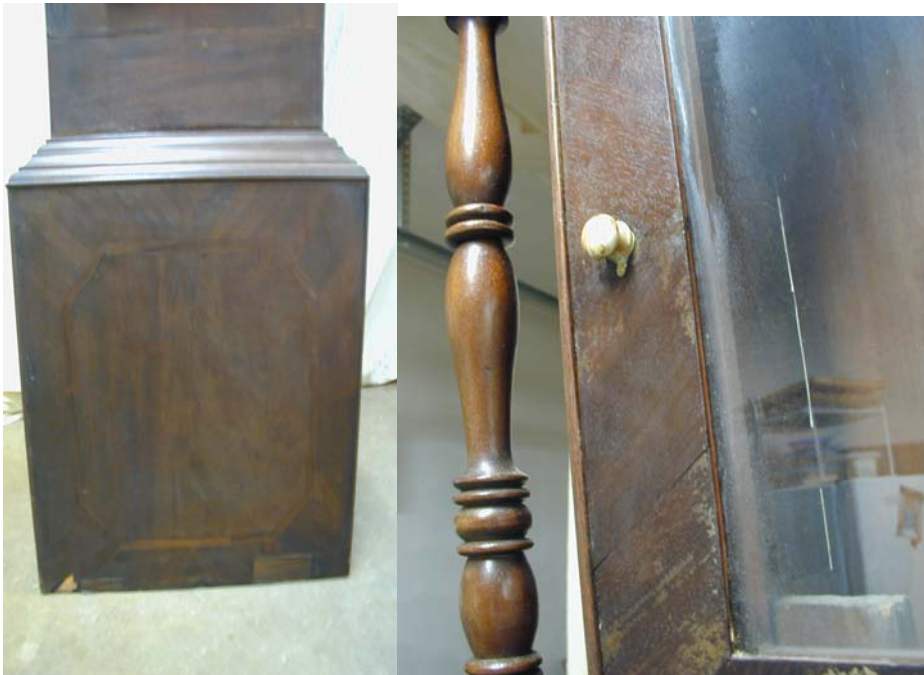
Fair. The case has been worked on previously and not well. There are a number of bad veneer repairs and veneer is missing. Three finials on the hood is missing. the feet (probably Ogee bracket) and plinth are missing.
